## Gangway Failure

For further information, email [alerts@nopsa.gov.au](mailto:alerts@nopsa.gov.au) and quote Alert number 36.

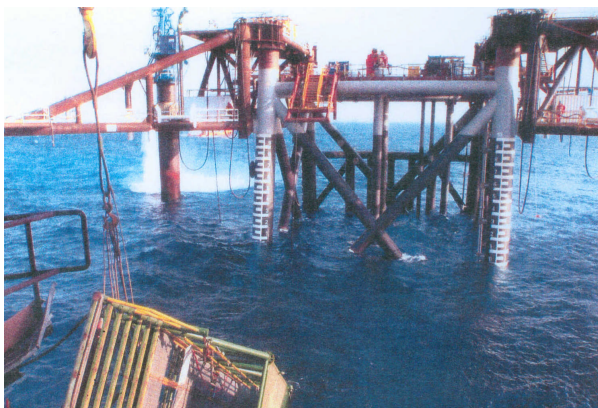
Although slings and chains were placed on the gangway and connected to the landing platform they were too long to prevent the gangway from dislodging from the landing platform, and were of insufficient strength to withstand the impact loads and prevent the gangway from falling into the sea.

The gangway collapsed into the sea

2. Secondary fall protection arrangements must be properly engineered and specified in the installation, operation and maintenance procedures for gangways.
3. These operation and maintenance procedures also need to provide for close visual inspection at least once per shift when the gangway is in use.

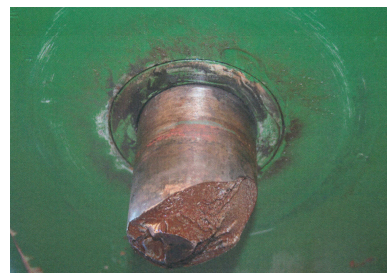
A purpose-built project modular gangway for jacket access from a construction barge parted at the jacket end and fell into the sea. To allow for movement of the construction barge, the gangway had a roller support at the barge end and was supported by a gimbaled joint at the platform jacket end. The failure occurred in the vertical pin of the gimbaled joint.

Investigation determined that a weld around the centre of the pin was omitted during the fabrication process, which would have increased the stress levels in the pin. It was further determined that the incorrect grade of steel for the pin was ordered, although the yield stress of the steel was as specified in the design.

The failed gimbal pin

1. Fabrication yard quality assurance must include a thorough inspection to ensure that the design and specification have been met. These need to include checks that all specified welds have been made, not just Non-Destructive Testing (NDT) of the welds that have been made, and that mill certificates for the steel used matches the grade that was specified, not just in relation to yield stress.
