## Planned Inspection

Facility: Northern Endeavour - NOGA  
Operator: Upstream Production Solutions Pty Ltd  
Offshore Inspection Dates: 19/04/2017 – 21/04/2017

Report Number 1505

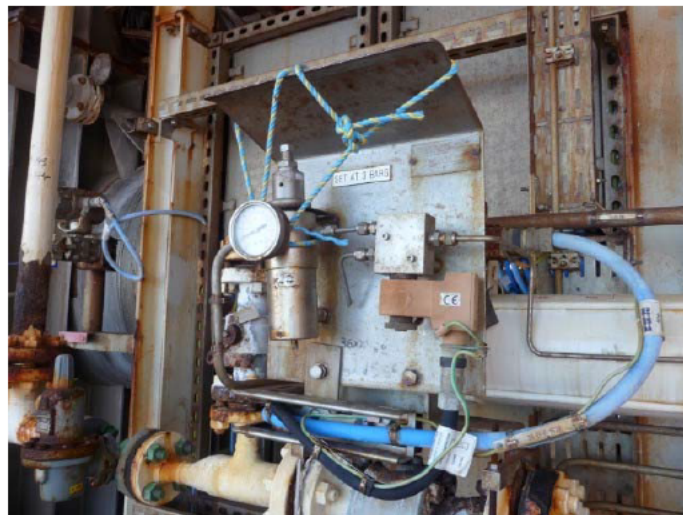
**Figure 1 - Instrument Air Tubing Arrangement**

The inspectors did not identify any tubing installations on the facility, in hydrocarbon service, with obvious installation defects. At least one example (Figure 1) was sighted of an instrument air tubing installation with a temporary supporting arrangement, likely due to corrosion of the existing supports. It should be noted that this example was isolated and does not indicate imminent loss of hydrocarbon containment; however it may indicate a lack of inspection and maintenance of tubing installations.

<b>Recommendation 1505-14</b>
UPS to consider preparing an asset register for all small bore tubing systems so that maintenance, inspection and repair activities can be scheduled in the computerised maintenance management system (CMMS).
