| <b>Document Title</b> | <b>INVESTIGATION INTO THE UNCONTROLLED RELEASE OF HYDROCARBONS FROM THE MONTARA WELLHEAD PLATFORM ON THE 21 AUGUST 2009 – EXPERT WITNESS REPORT</b> |
| <b>SW Doc Ref.</b> | <b>RPT-30291-NOPSA-001 VOLUME 2</b> |
| <b>Date</b> | <b>17 February 2012</b> |

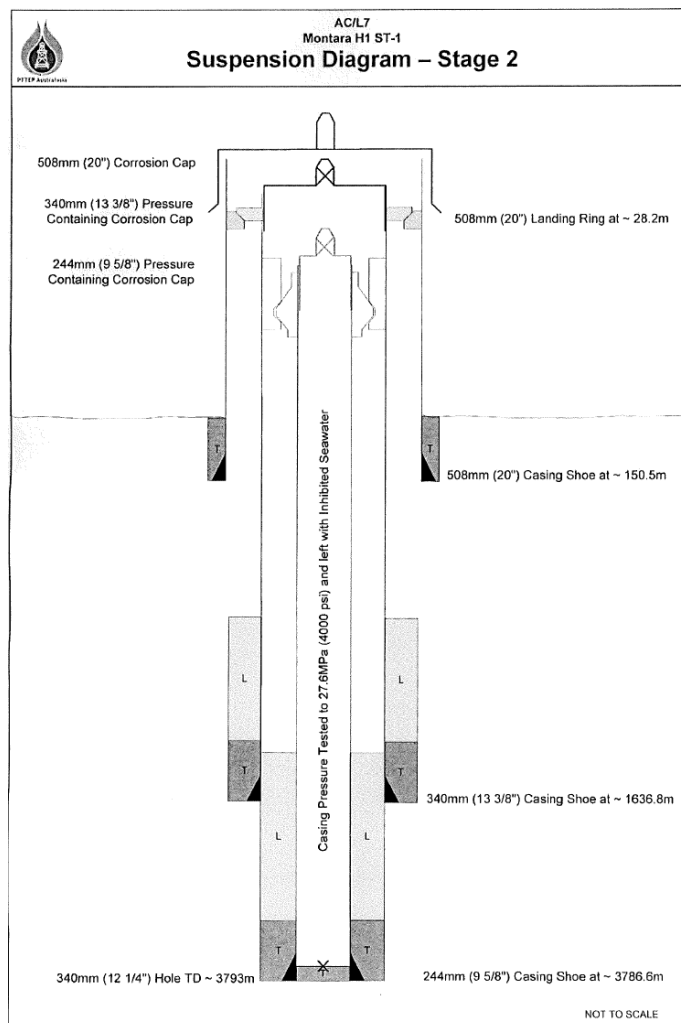
Document [27], dated 12 March 2009, is an application by PTTEPAA to the NT, requesting approval to suspend Montara H4 and perform Stage 2 suspensions on GI-ST1 and Montara H1-ST1 development wells, AC/7 in accordance with Drilling Programme (TM-CR-MON-B-150-0001 Rev 2). The proposed programme seeks approval to perform 2<sup>nd</sup> Stage suspension of H1-ST1 as per attached suspension diagram.

2<sup>nd</sup> Stage: Recover 13 3/8" (340mm) casing above the MLS, Install a second PCCC, Recover 20" (508mm) casing above MLS and Install a further suspension cap.

| <p>During the Re-entry of H1-ST1, on 20 August 2009, where it was found that the 13 3/8" (340mm) PCCC was not installed as proposed in Document [27].</p> |

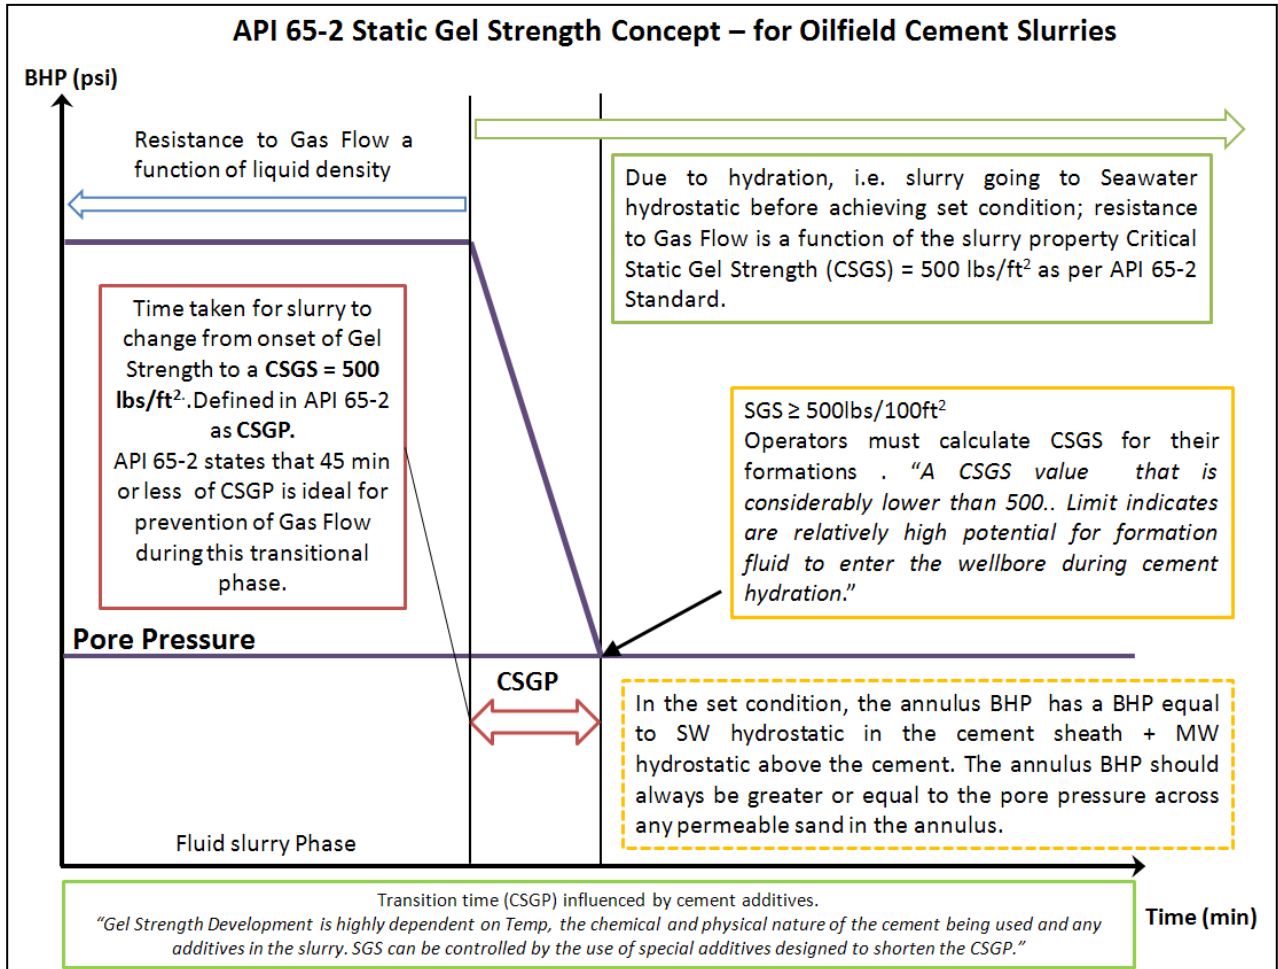
**Figure 1: The Expert’s interpretation of API 65-2 Static Gel Strength Concept for Oilfield Cement Slurries**

4. API Standard 65-2 section 5.7.8 “Static Gel Strength” describes the significance and impact of the hydration behavior of cement slurries. “Static Gel Strength (SGS) development is one of the many factors that contribute to decay of hydrostatic pressure. The cement slurry undergoes a chemical reaction between the water, additives and dry cement, driven by temperature, which causes a change of state from gelled fluid to a solid over a period of time. At some point the slurry reaches the CSGS where the cement column loses its ability to transmit hydrostatic pressure. Once the SGS reaches a value of 500 lbs/ft<sup>2</sup> (the CSGS), it is commonly accepted that at this value gas cannot move freely through the column. Therefore the exposure period whereby hydrocarbons (in particular gas) could flow through the cement is the time difference between full hydrostatic transmissibility and an SGS=500 lbs/ft<sup>2</sup> (the CSGS). This period of time when gel strength starts to develop, reducing hydrostatic transmissibility and SGS = 500lbs /ft<sup>2</sup>, is known as CGSP, Critical Gel Strength period. One *method recommended by API 65 to evaluate the impact of the gel strength development on wellbore fluid influx is to calculate the CSGS and then to measure the CGSP.”*

5. The cement recipe or laboratory testing by Halliburton for the 9 5/8” (244mm) casing cementation did not include a measurement of either CSGS or CGSP. Therefore the Expert Witness cannot comment on the effectiveness of this slurry to resist gas migration into the annulus during the transitional phase.

Figure 1 is the Expert Witness’s illustration of the concept described in point 4.

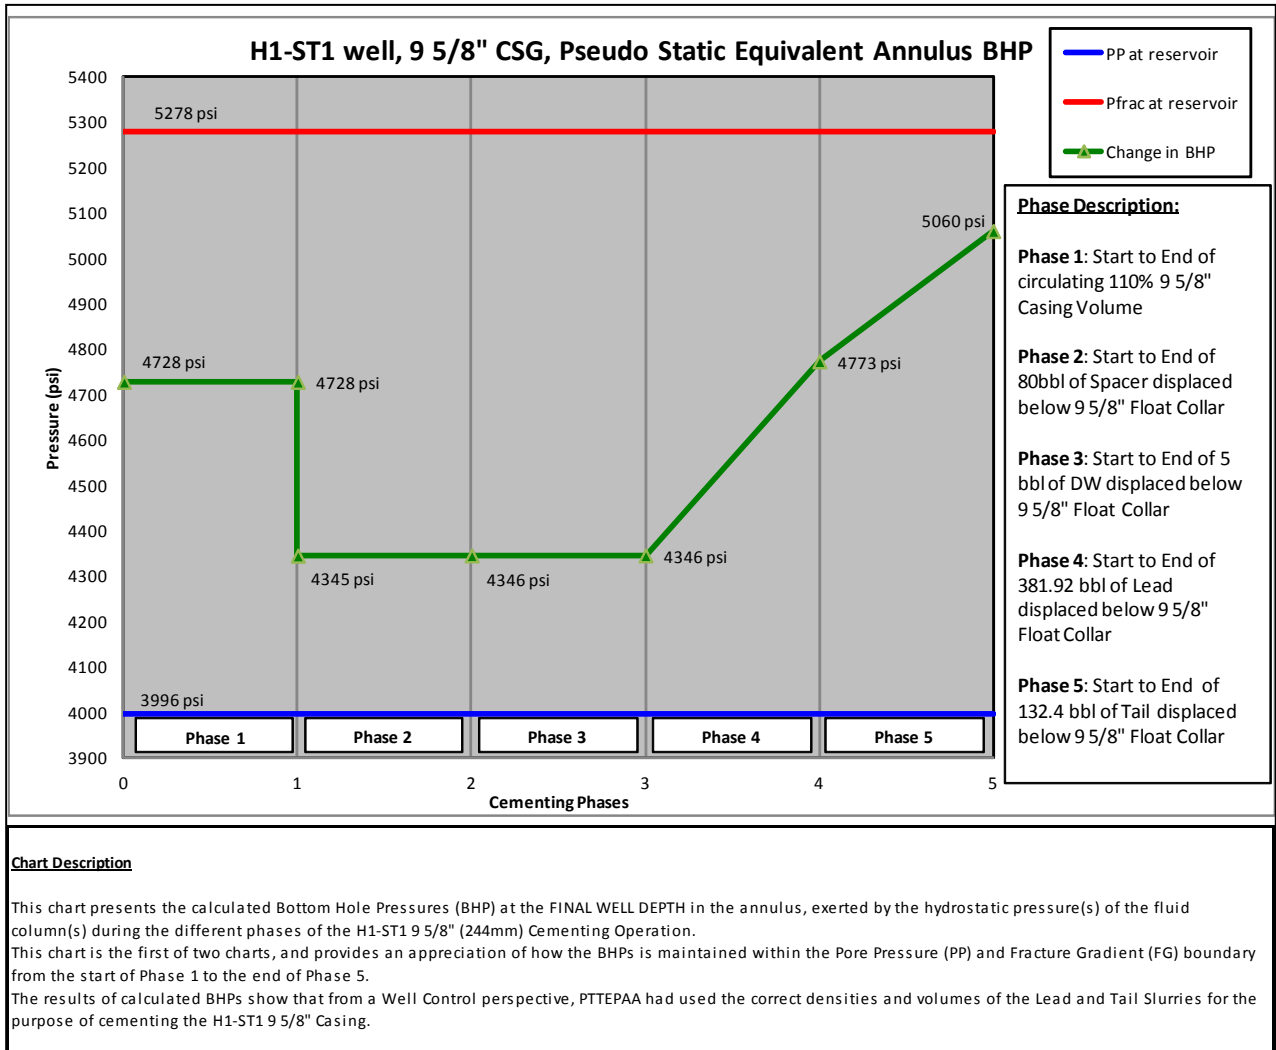
**Figure 2 : H1-ST1 well, 9 5/8" (244mm) CSG, Pseudo Static Equivalent Annulus BHP**

The hydrostatic pressure exerted by the cement columns (Tail and Lead Slurry) in the annuli create the BHP overbalance against the Montara Cycle IV reservoir and consequently affect the risk of hydrocarbon flow up the annulus. At the end of cement displacement, in the dynamic slurry condition, an adequate overbalance of 1064psi (5060psi -3996psi), Figure 2, End of Phase 5, existed to the Montara Cycle IV reservoir.

The hydrostatic pressure exerted by the cement column in the annulus has no bearing on the hydrocarbon flow potential through the casing. Prevention of uncontrolled flow via the casing is normally provided by the BPVs in the casing shoe, and if they fail, the hydrostatic column of fluid in the casing. At the time of pumping the tail slurry, PTTEPAA would have assumed the BPVs to have been functional. The displacing fluid in this case was a seawater column and not an overbalance fluid.

The volume of tail could only have influenced the risk of uncontrolled hydrocarbon flow through the casing if the volume of tail and the lead slurries did not generate sufficient hydrostatic pressure to create an overbalance to the reservoir and there were intentionally no back pressure valves in the casing shoe, and a deliberately underbalanced displacing fluid, none of which was the case.

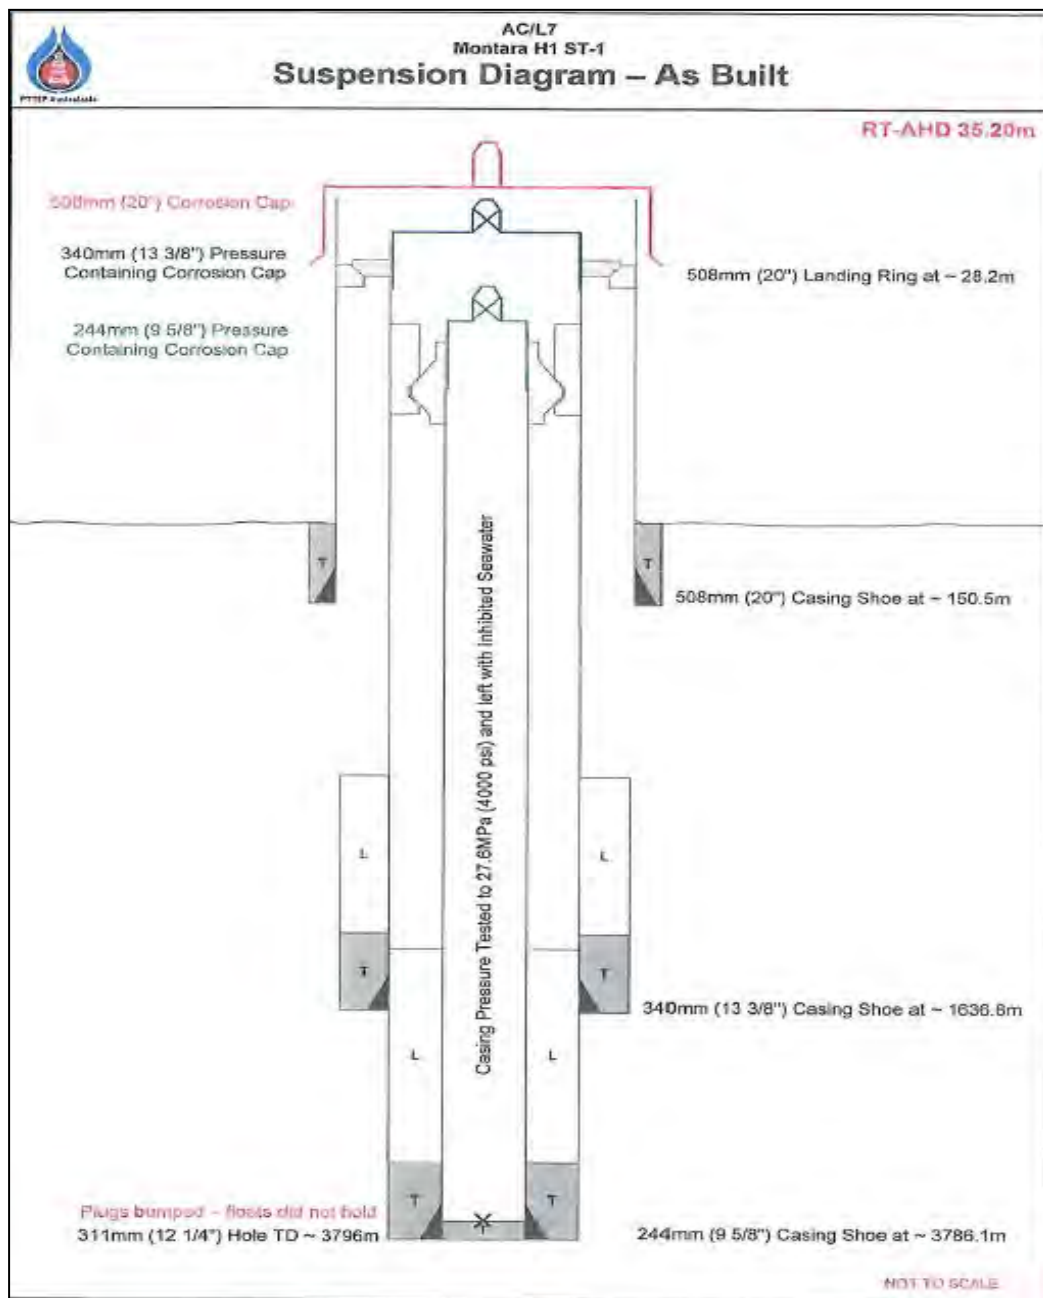
The "AC/L7 Montara H1-ST1 Suspension Diagram – As Built" (Page number was not provided in the Program) shown below, contains several errors with regards to well barriers:

1. The 13 3/8" Pressure Containing Corrosion Cap is shown as a barrier in the Suspension Diagram, when in actual fact it had not been installed.
2. The rat-hole and shoe track had been isolated with cement, when in fact 9.0 bbl of seawater had been over displaced after the floats had failed, leading to seawater residing in the shoe track, rathole and annulus space.

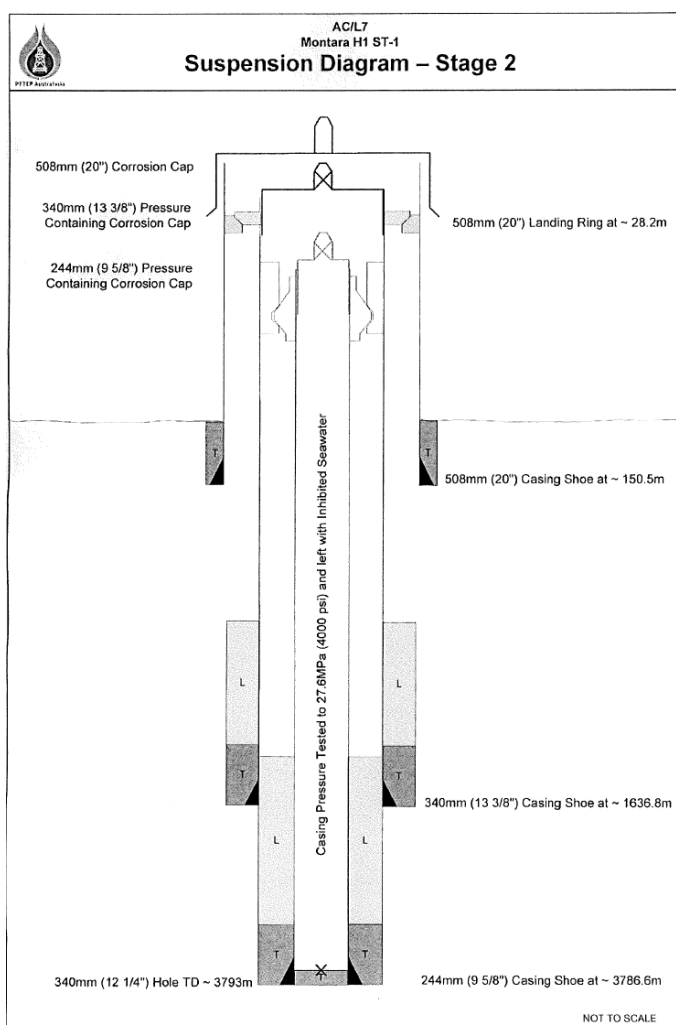
**9th Event/Change:** Letter request dated 12 March by PTTEPAA to NT requesting approval to suspend Montara H4 and perform Stage 2 suspensions on Montara GI –ST1 and Montara H1-ST1 development wells, AC/7, using the rig.

Note: Stage 2 was executed on 16 April 2009 as an OFFLINE activity. The NT authority had been informed from [4] that the installation of the 20” trash cap would be installed offline but this programme was issued on 6 January 2009 several months before the suspension method was changed to include 9 5/8” (244mm) and 13 3/8” (340mm) PCCC’s. Document [13], paragraph 3 states the following:
