Impact of Sea-State on Lifting Operations

For further information email alerts@nopsa.gov.au and quote Alert 35.

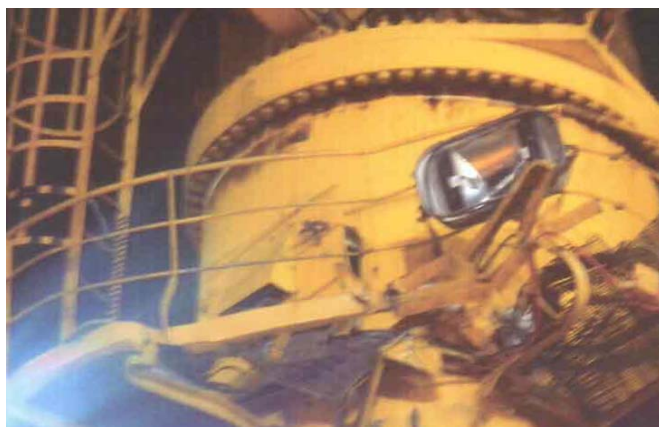
Case 1 – The first incident (in Australian waters) occurred during lifting operations on a construction support vessel. While lowering a crane block to the deck, a large swell hit the vessel inducing a rolling motion and causing the block to swing. Despite efforts of the crane operator to control the swing, the block collided with an empty product reel (dislodging its sea fastenings), an air-conditioning unit and the walkway of another crane before it could be recovered to a safe height. Personnel in the vicinity of the lifting operation had earlier moved clear of the lifting area and nobody was injured, however the incident resulted in minor damage to the equipment struck by the block.

Damage to crane walkway and light caused by impact of swinging block.

Both of these incidents resulted from a combination of poor planning of lifting operations and lack of suitable risk assessment to identify potential hazards and implement appropriate risk control measures. In particular, both lifting operations were conducted in congested areas where there was potential for vessel movement to result in lifted equipment impacting with surrounding structures, and while safer options had been identified, they had not been used.

Lifting operations are one of the most hazardous operations conducted on offshore facilities and require careful planning, identification of the hazards, assessment of risks and implementation of appropriate controls. It is important that any changes in circumstances, such as congested lifting areas and potential changes in sea-state which could lead to unpredicted movement of a suspended load, are given appropriate consideration in the task safety analysis.

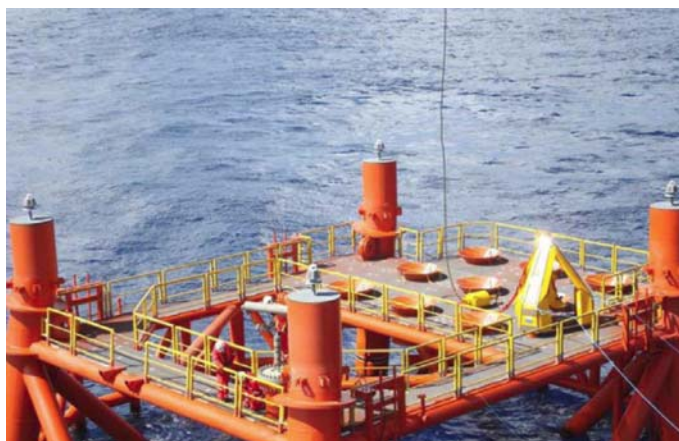
Case 2 – The second incident (outside Australian waters) occurred during personnel transfer operations between a recently installed platform jacket and a vessel. Three people, who were involved in the commissioning activities for the recently installed jacket, were preparing to transfer back to the vessel and entered the personnel lifting device. Prior to the actual lift, a swing developed in the crane's headache ball due to a worsening sea swell. Despite efforts of the crane operator to control the swing, the swing gathered momentum until it eventually hit one of the platform legs and ricocheted into the frame of the personnel lifting device, striking one of the occupants. The injured person was taken to hospital but released later that day.

Platform jacket showing personnel lifting device and crane wire.
