Appendix D: Environmental Performance Report for Baleen MSS

BALEEN 2D HR SEISMIC SURVEY

ENVIRONMENTAL PERFORMANCE REPORT

Petroleum Exploration Permit 11 (PEP11)
Offshore Sydney Basin
July 2018

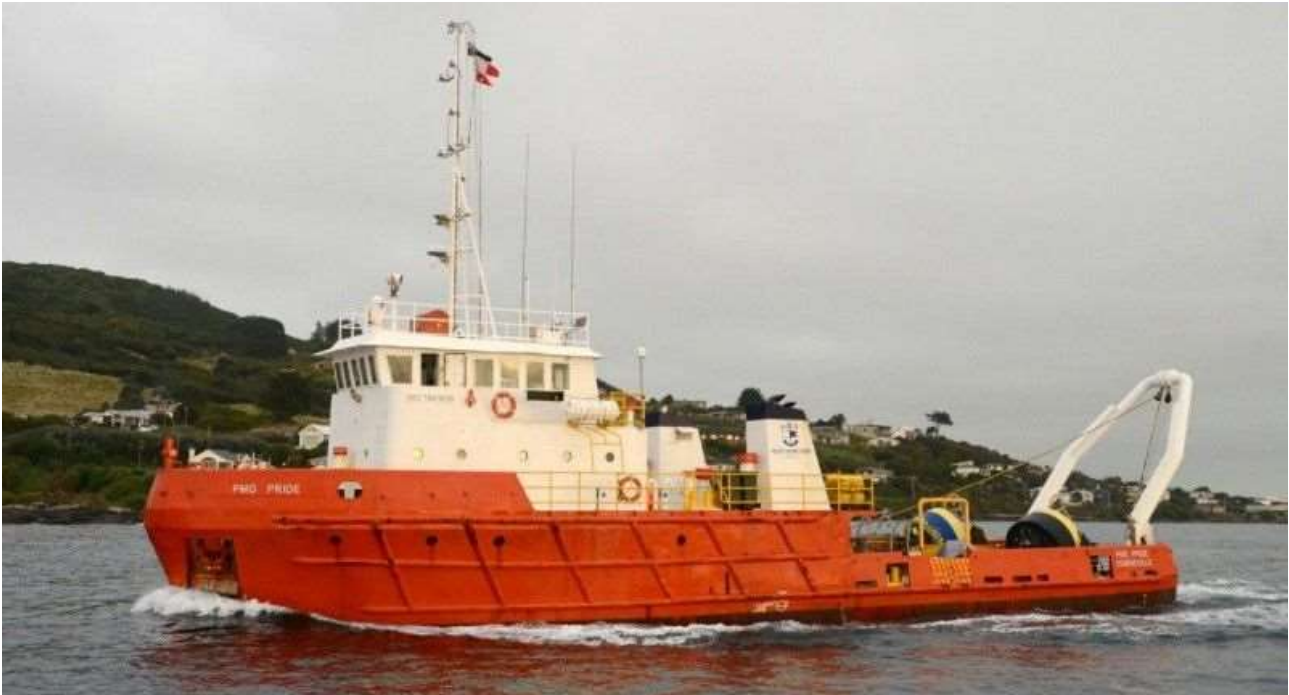
Figure 3 – PMG *Pride*. Source: Pacific Marine Group

The survey was conducted by the PMG *Pride*, an Australian utility vessel converted to tow seismic equipment (Figure 3).

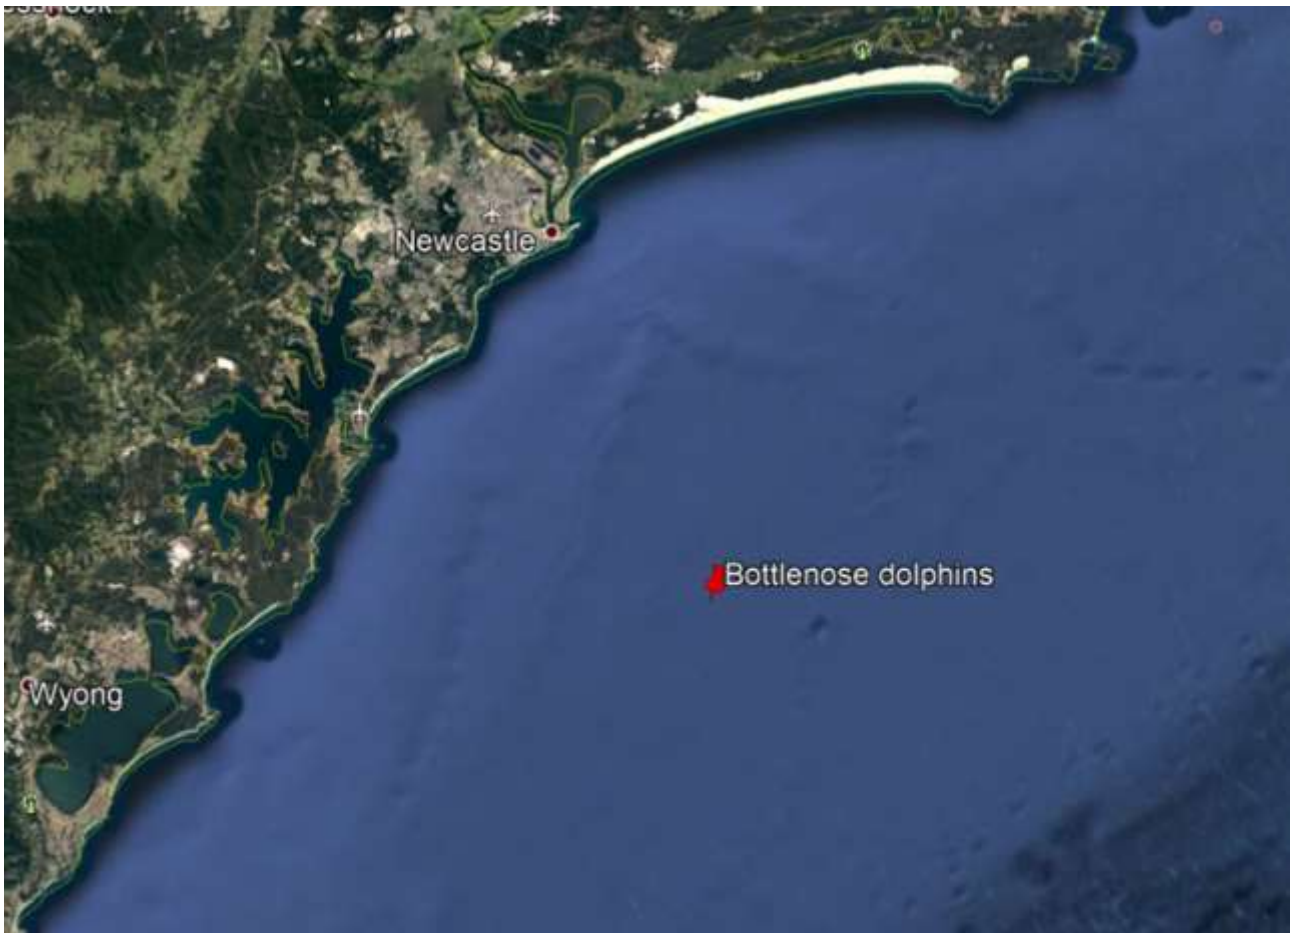
Figure 8 - Location map detailing the cetacean sighting during the Baleen 2D HR seismic survey, relative to the coast

Sight No.	Date	Initial Sighting or Shutdown Time (AEST)	Vessel Position (lat/long)	Distance from Source (m)*	Species	No. of Animals	Behaviour	Seismic Status	Mitigation Action	Line No.
1	16/04/2018	16:38	33° 9.166' S 151° 57.15' E	1986	Common bottlenose dolphin (<i>Tursiops truncatus</i>)	15	Fast swimming	Full power	Powerdown	B18-46

1. At 16:36 (AEST) on 16 April 2018 a pod of bottlenose dolphins was observed, approximately 2921m from the source. The pod was fast swimming and at 16:38 was observed 1986m from the source and within the 2000m mitigation zone. The instrument room was notified and the acoustic source was powered down immediately. At 16:39 the pod was observed 531m from the source. As per Section A.3.5 of the EPBC Act Policy Statement 2.1, since the dolphins were about to enter the shut-down zone, the acoustic source was shut down immediately. At 16:57 the animals were observed outside the 2000m mitigation zone, but the line was aborted and the vessel commenced a line change. The line (B18-46) was re-acquired on the 19 April 2018.
