## Pre-flight checks for life jackets and compressed air emergency breathing system (CA-EBS)

Date: Tuesday, 8 August 2023

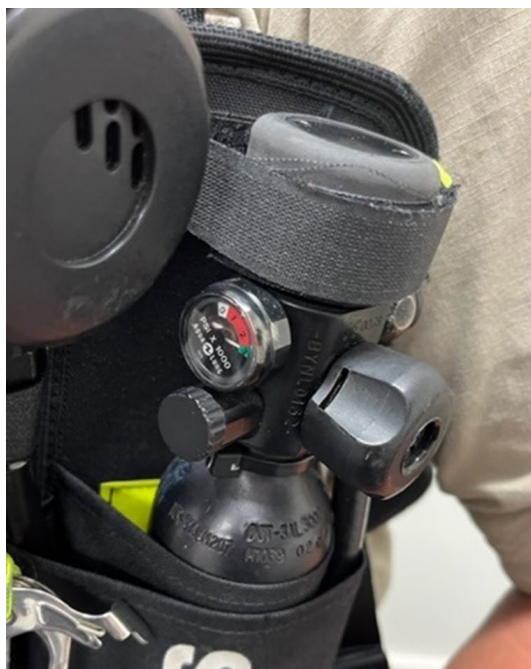
3. Passengers assumed the lifejackets and CA-EBS were correctly donned and operational after the heliport staff checks.
4. The CA-EBS indicators to show correct pressure was available were misleading. The photograph below shows the air tank has adequate pressure (that it’s ‘in the green’). However, no indicator shows which way the valve should be opened or closed and in this instance the valve was actually closed.

- Prior to departure, lifejackets should be checked by two independent parties to confirm that they are being worn properly, and all safety systems are functional and operable. E.g.
  - A buddy traveling on the same flight as each passenger
  - Heliport personnel (after the buddy check), who have appropriate competency in checking the lifejackets and CA-EBS.
  - Other competent parties as appropriate
- Heliport personnel should have clear understanding of how lifejackets and CA-EBS should be donned and set up to ensure correct operation.
- Lifejackets should have clear markings to ensure the CA-EBS can be checked for correct operation.
