SAFETY ALERT 34

Bulkhead and Deck Fires

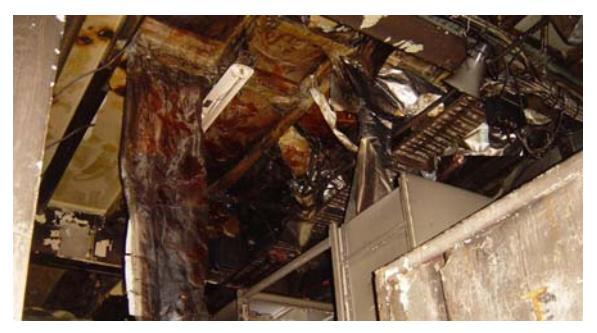
Case 1 – "Flame-washing" was being conducted to remove welded tie-rods. The deck where the work was being carried out formed a ceiling to the main store. Combustible material had been used as insulation in the deck-head which resulted in a significant fire and explosion.

Fire damage to the main store initiated from "flame washing" on the deck above.

Control of combustible material is critical. Deck-heads should be inspected prior to any hot-work. The combustibility of all insulation or other material in close proximity to the deck or bulkhead should be clearly established. Insulation fitted during shipyard refits must be inspected to ensure it is not readily combustible.

Appropriate consideration of the requirement for firewatchers both at the work site *and* on the other side of bulkheads and decks should be given during permit preparation.

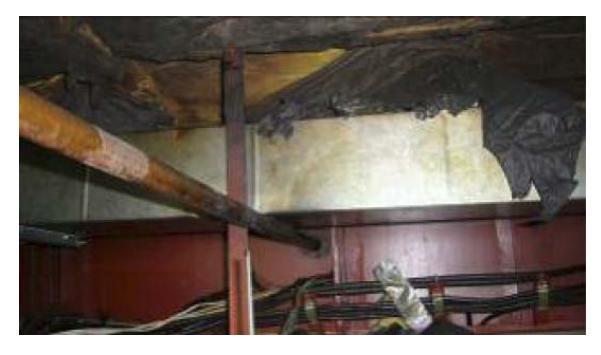
Case 2 – Welding was conducted to fix patches in a corroded and leaking deck. Insulation under the deck was inspected prior to the job; however the combustibility of the insulation material was not recognised. Smoke was seen emerging from cabin roof spaces which triggered the evacuation of accommodation and a general muster.

Fire damage to ceiling space initiated by welding on the deck plate above

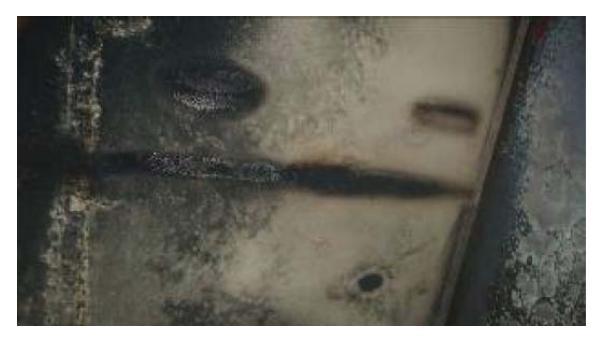
Case 3 – A bundle of clean rags in a store was ignited following welding on a deck above.

Typical burnt paint from radiant heat associated with the welding on the main deck above
