Crane Overhead Windows Dropped Object Protection**What happened?**

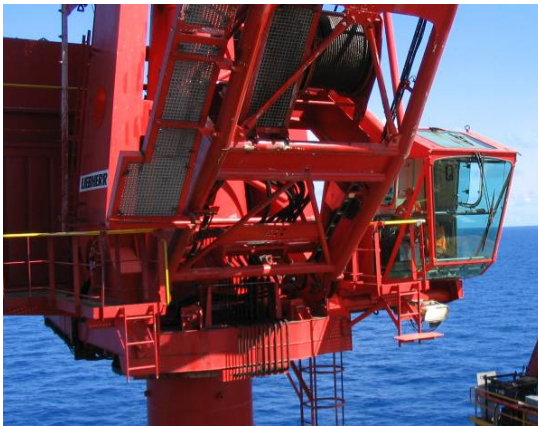
During a recent NOPSA inspection of an offshore facility it was noted that the pedestal cranes on the facility did not have any grating protection for the overhead windows of the crane. Figure 1 shows a crane without drops protection and figure 2 shows a crane with drops protection on the overhead window.

Figure 1 – no drops protection.

In carrying out a hazard and risk assessment of crane operations, the last line of defence or last line escalation factor against dropped objects affecting the crane operator is a physical barrier. Safety glass will not provide the same physical protection against dropped objects as a steel grating.

It is recommended that all operators carry out an assessment to confirm crane overhead windows are physically protected and not just reliant on safety glass.

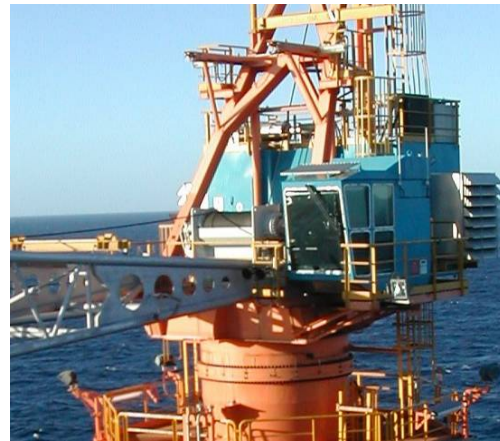
Figure 2 – with drops protection

The American Petroleum Institute (API) specification 2C section 12.2 recommends that if a crane cab is equipped with an overhead window, a grating or other protection should be placed over the window to prevent debris from falling on the operator.
